DEPARTMENT OF TRANSPORTATION**DIVISION OF ENGINEERING SERVICES**

Office of Structural Materials

Contract #: 04-0120F4Cty: SF/ALA Rte: 80 PM: 13.2/13.9File #: 69.28**WELDING INSPECTION REPORT****Resident Engineer:**Siegenthaler, Peter**Address:** 333 Burma Road**City:** Oakland, CA 94607**Report No:** WIR-021878**Date Inspected:** 02-Nov-2010**Project Name:** SAS Superstructure**OSM Arrival Time:** 700**Prime Contractor:** American Bridge/Fluor Enterprises, a JV**OSM Departure Time:** 1900**Contractor:** Zhenhua Port Machinery Company, Ltd (ZPMC), Changxing Island **Location:** Shanghai, China**CWI Name:** Xu Le Feng /Qiu Wen**CWI Present:** Yes No**Inspected CWI report:** Yes No N/A**Rod Oven in Use:** Yes No N/A**Electrode to specification:** Yes No N/A**Weld Procedures Followed:** Yes No N/A**Qualified Welders:** Yes No N/A**Verified Joint Fit-up:** Yes No N/A**Approved Drawings:** Yes No N/A**Approved WPS:** Yes No N/A**Delayed / Cancelled:** Yes No N/A**Bridge No:** 34-0006**Component:** OBG Bike Path**Summary of Items Observed:**

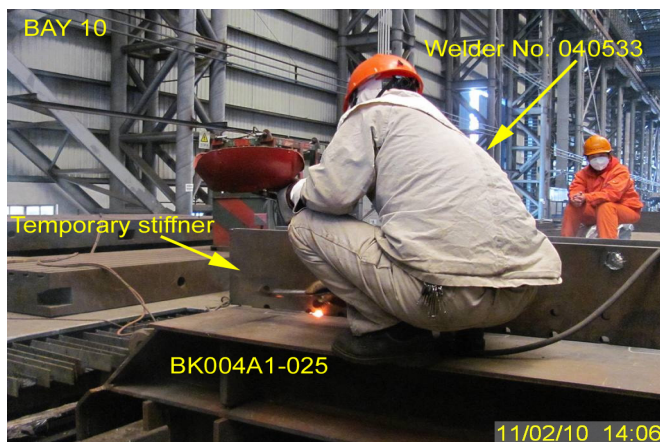
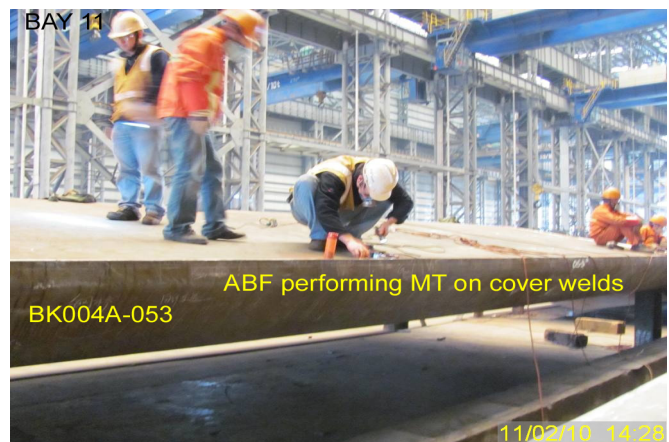
This QA inspector performed MT of approximately 15% of an area that has been previously tested and accepted by ZPMC Quality Control (QC) personnel. This QA Inspector generated an MT report for this date.

BK004ASD1-053-009, 010, 011, 012, 013, 015, 016, 017, 019, 020, 025, 026

Unless otherwise noted, all work observed on this date appeared to generally comply with applicable contract documents.
